# Surface Preparation and Coating

## A practical solution to the repair of ballast tank coatings

**In this article by our contributor Brian Goldie, in conjunction with Bert Kok of Royal Coatings, the Netherlands, this topic of BT coatings is examined.**

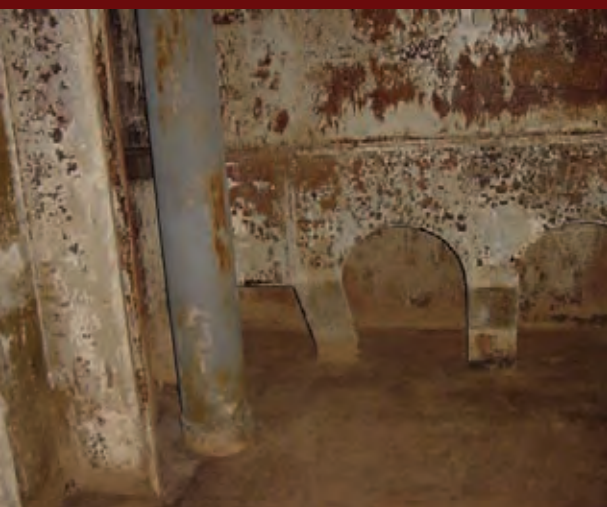
*Typical condition of Ballast Tank Coating after a number of years.*

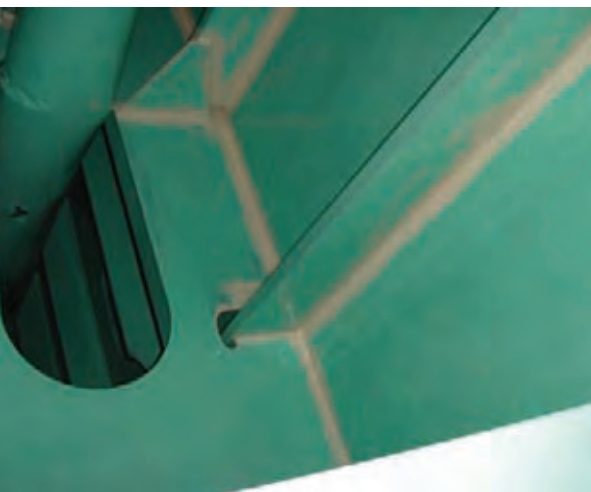
After curing for eight hours, a stripe coat is applied at edges and weld seams (or could be applied wet-on-wet), followed by one coat of EasyFlex,

Stripe Coating.

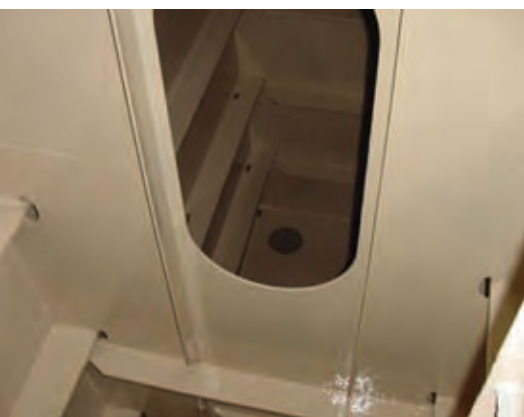
EasyFlex finish coat.

again applied by brush, roller or airless spray at 250 – 300 µm. The tank can then be returned to service after 18 hours at 20° C, without holiday testing. The completed coating system can then be optionally guaranteed for 5 years (or longer).

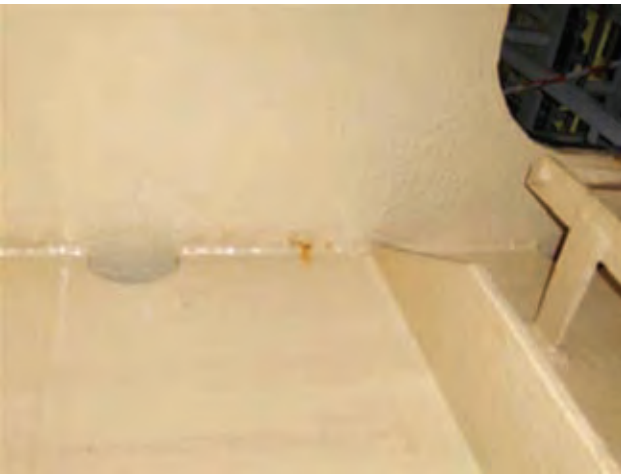
This vessel has just been inspected (September 2007) after some tanks had been coated for more than eight years and found to be in better than GOOD condition as defined in the PSPC standard. There was only minor coating repair in

*Soltaire, Ballast water tank coating after eight years service.*
